Kotlik: Background Report

Alaska Institute for Justice

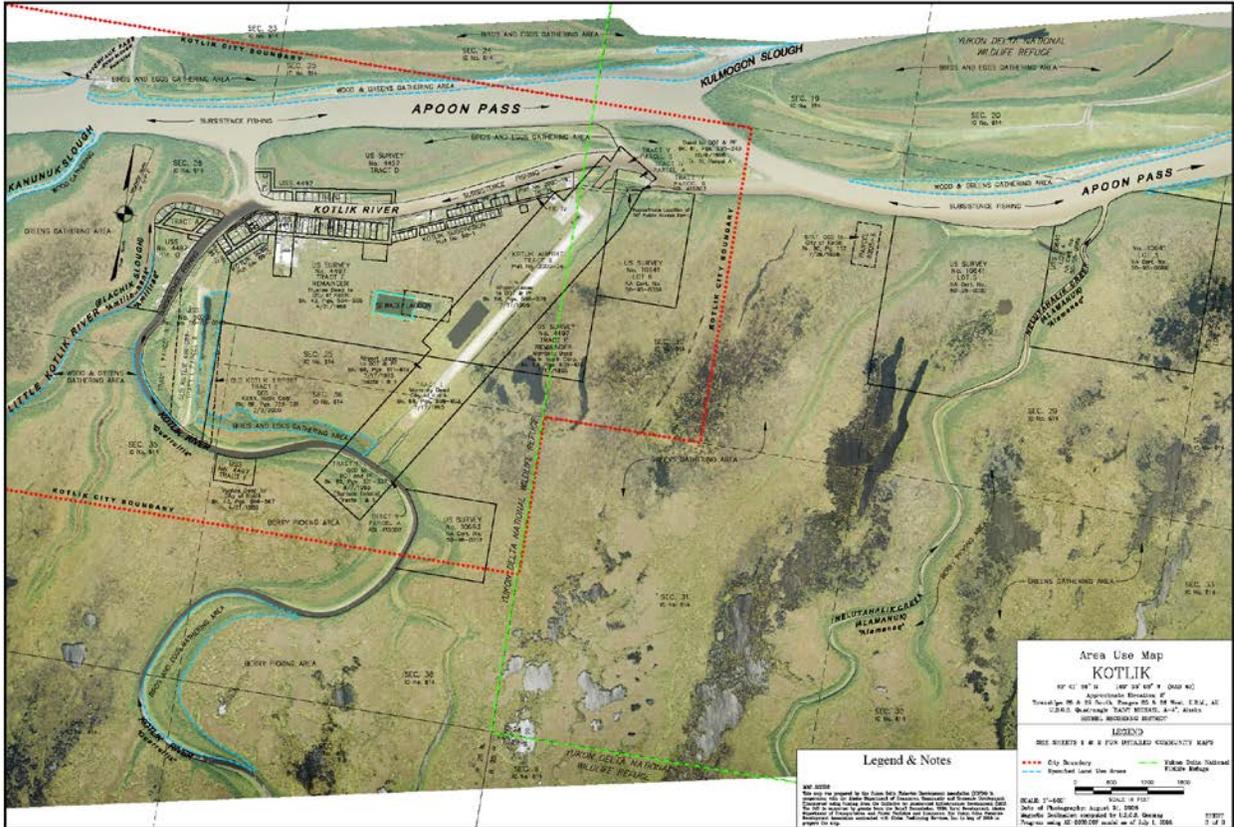
Figure 1: Kotlik Community Layout showing subsistence gathering areas, sewage lagoon, airport and homes (Map produced by Yukon Delta Fisheries Development Association and Alaska Department of Commerce, Community & Economic Development (2006). Retrieved from Division of Community and Regional Affairs Community Profile Maps, <http://dced.maps.arcgis.com/apps/webappviewer/index.html?id=18fdb060875740fdad22099ca779d637>).

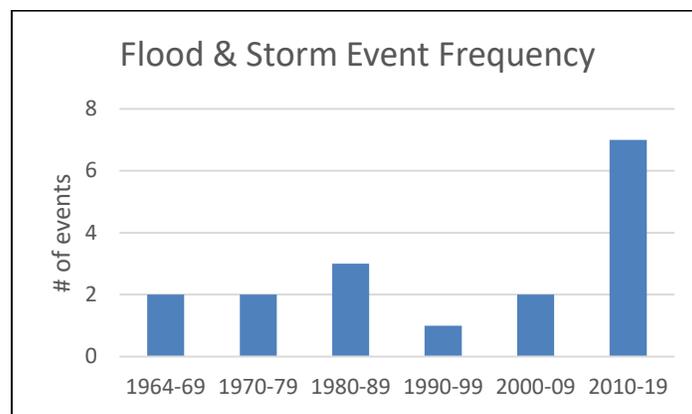
Figure 2: Recorded number of flooding and storm events between 1964 and March of 2019 (LHMP, 2013 p. 5-14 to 5-17; FEMA, 2013a; FEMA, 2013b; Mike, P., 1982; Tonuchuk, V., 1987; AIJ 2017a; AIJ 2017b; AIJ, 2017c; AIJ 2019). The graph includes storm, flooding, and severe cold events that were federally-declared disasters; records of historical flooding events reported by community members and agencies; and storm and flooding events documented by AIJ and community members through community monitoring reports. Other flooding and storm events have occurred since 1964, but the majority have not been documented.

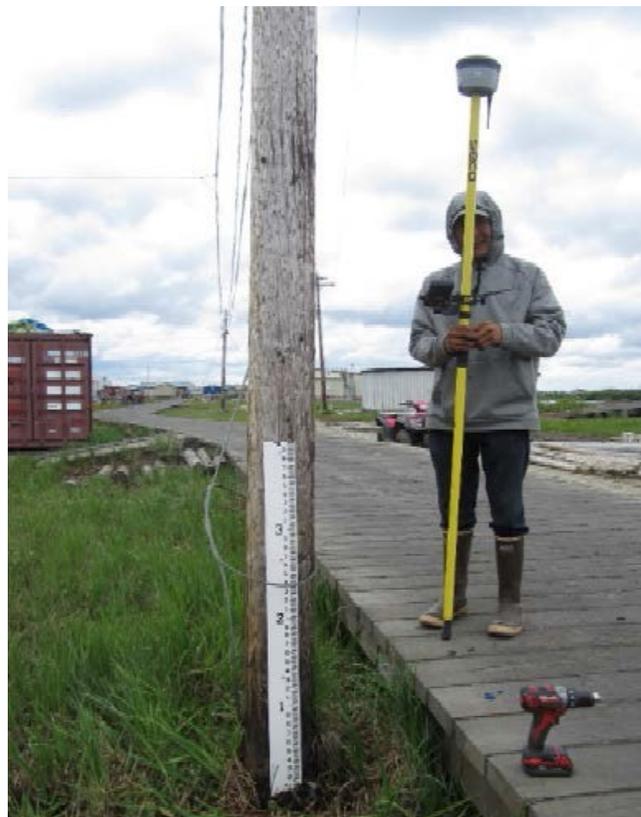
Figure 3: Emmett Matthias installing tide staff (Pollock 2017).

As a part of this documentation, in June 2017, AIJ and Kotlik community members collaborated with DGGs to install a tide staff on a telephone pole in a low-lying area that is frequently subject to flooding. The community uses the tide staff to monitor water levels and AIJ assists with documenting the information.

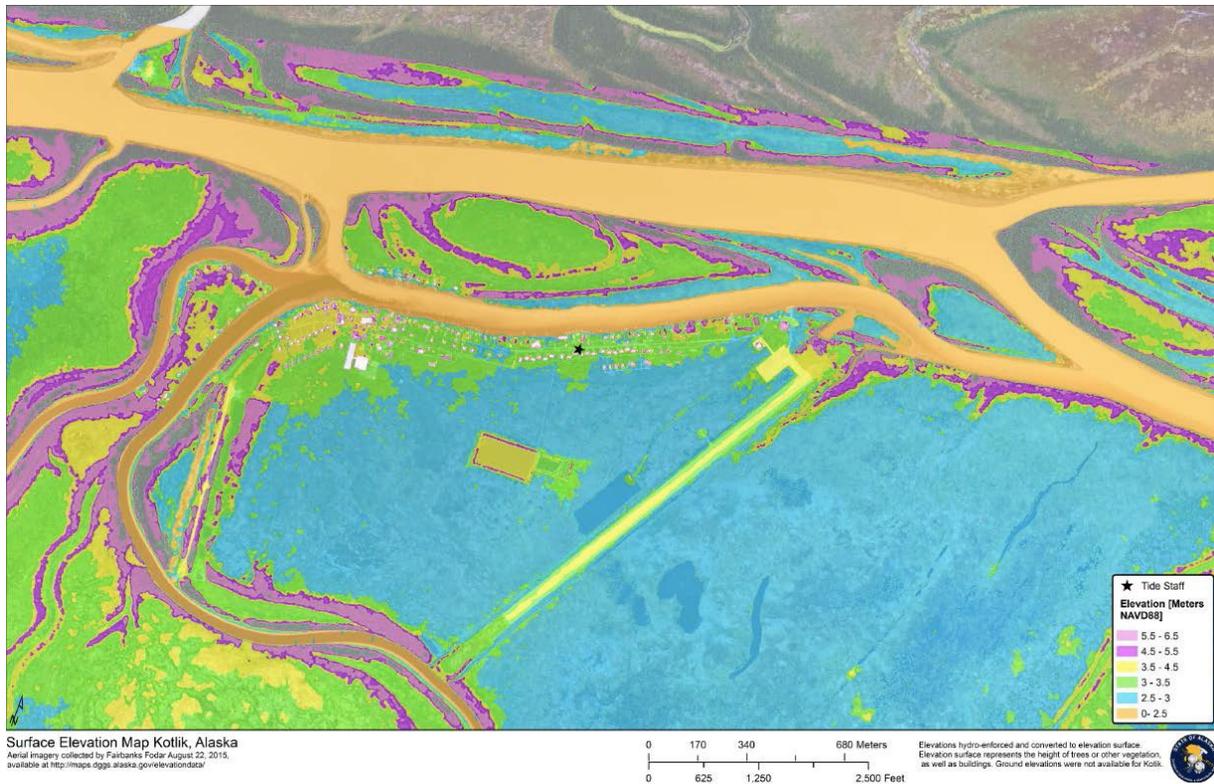
Figure 4: Preliminary map of digital surface elevation model of the Kotlik area, created by the Alaska Division of Geological & Geophysical Surveys (DGGS), Jacquelyn Overbeck, Jacquelyn.overbeck@alaska.gov in 2017. Elevation data are available at elevation.alaska.gov, are shown relative to the North American Vertical Datum of 1988 (NAVD88), and represent the tops of vegetation and buildings. In the Kotlik area, many vegetation types, including willows can be as much as a few meters in height above the ground surface.

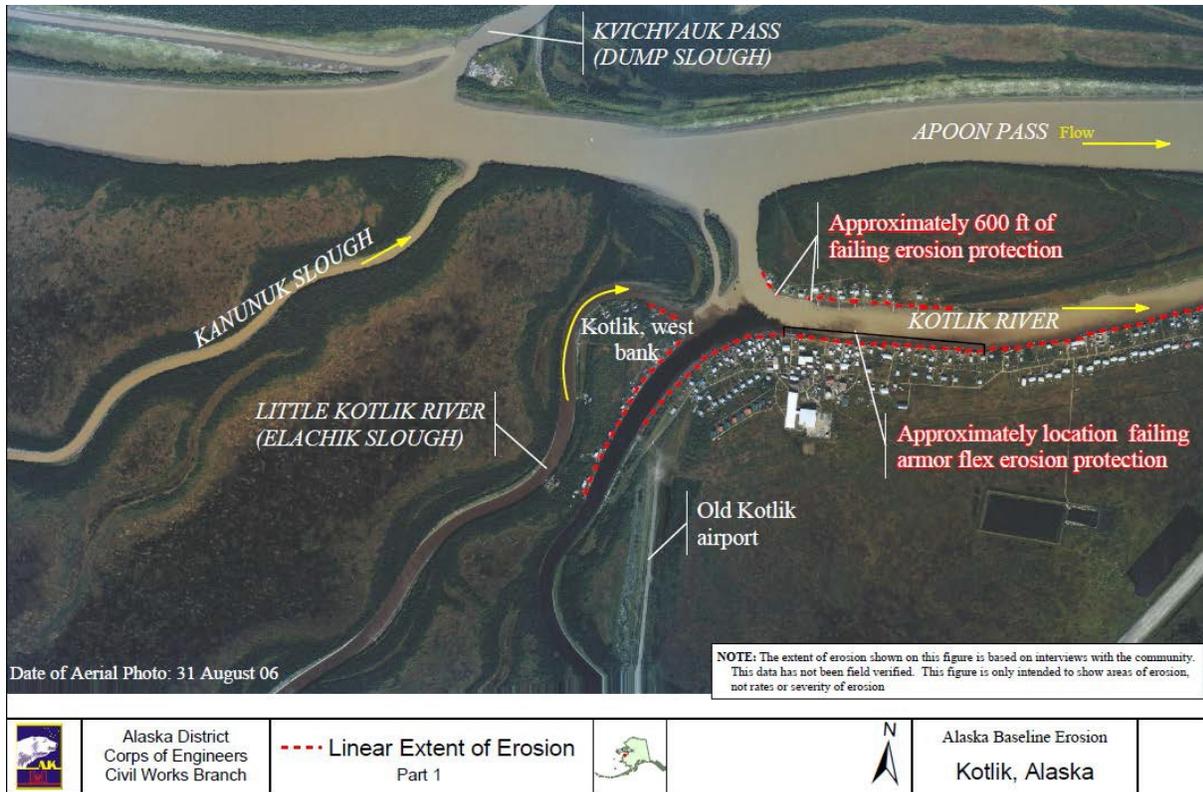
Figure 5: Linear Extent of Erosion in Kotlik (USACE, 2008, p. 4).

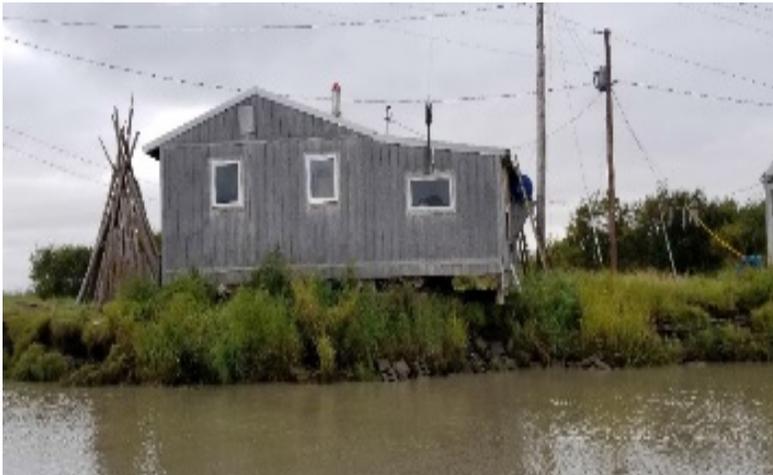
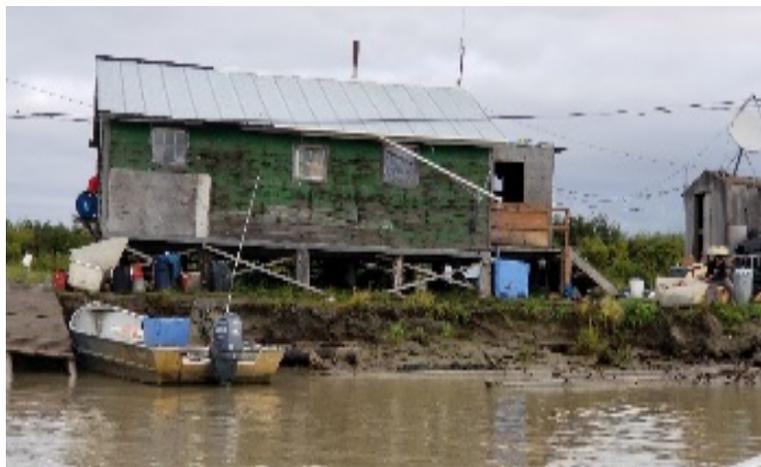
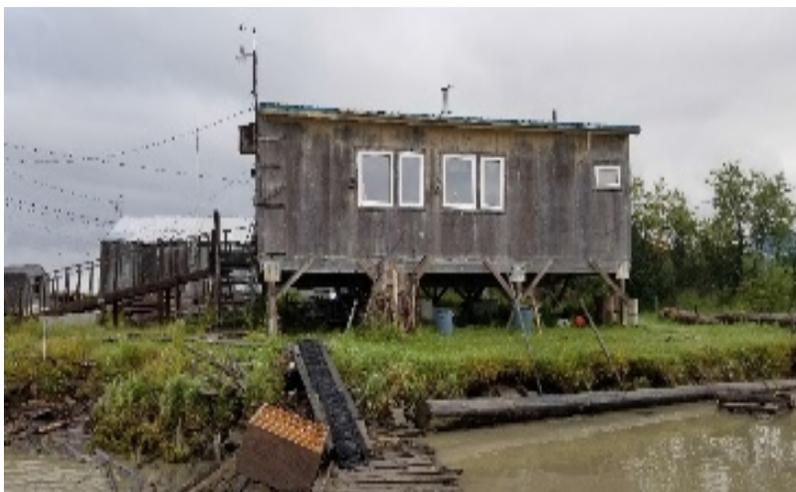
Figures 6-8: Three elders' homes immediately threatened by erosion that need to be relocated (Tanya Hunt, AIJ Personal Communications, August 2018).

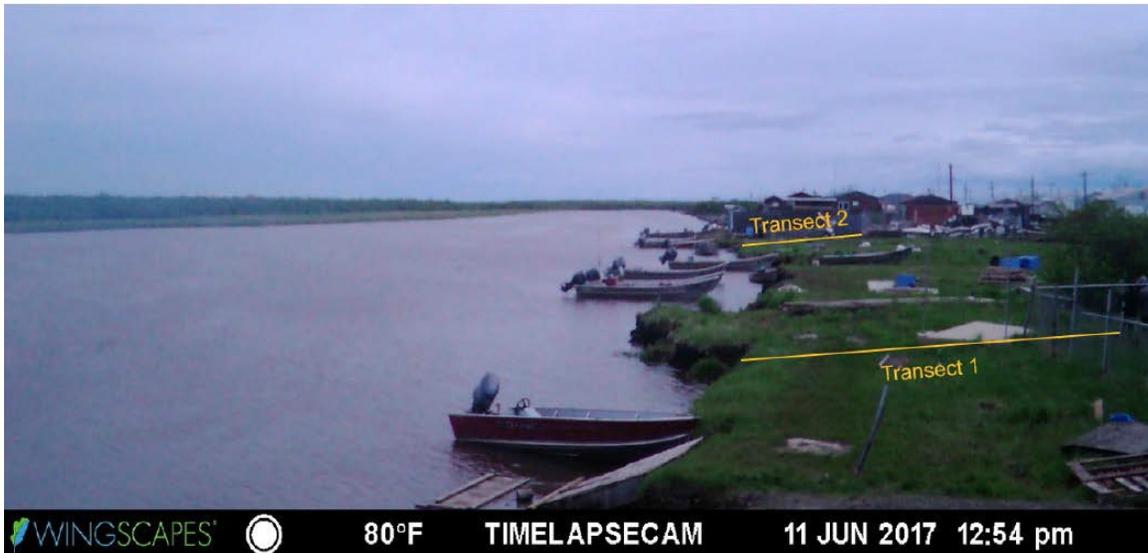
Figure 9: Time-lapse camera of Kotlik shoreline, provided by the Native Village of Bill Moore’s Slough and DGGs.

Erosion monitoring: In June 2017, in collaboration with DGGs, AIJ and Kotlik community members, installed erosion monitoring stakes in three locations and a time-lapse camera in one location near the Kotlik shoreline (Figure 9) to provide documentation of erosion. Local staff take measurements of the distance between the eroding riverbank and stakes at regular intervals.

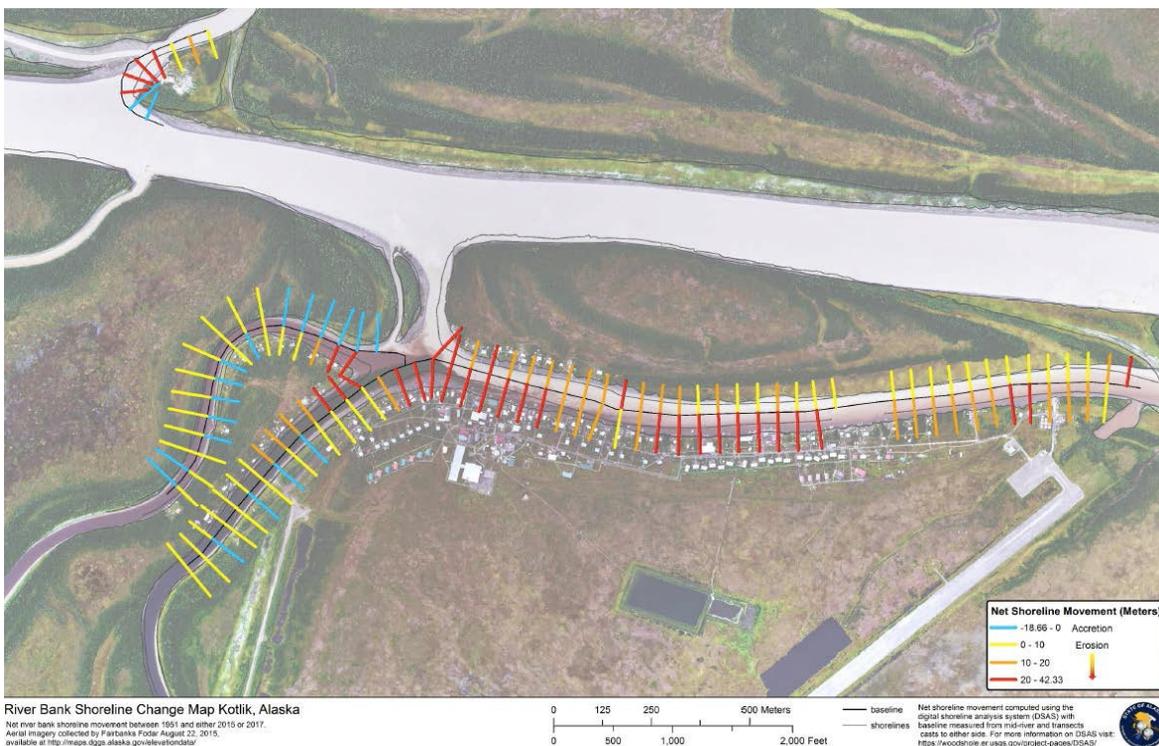
Figure 10: Preliminary riverbank shoreline change map of Kotlik showing the net shoreline (riverbank) movement from 1951 to either 2015 or 2017 (where data is available). Hot colors show areas of erosion and blue shows accretion. Created by DGGs, Jacquelyn Overbeck, Jacquelyn.overbecak@alaska.gov in 2017.

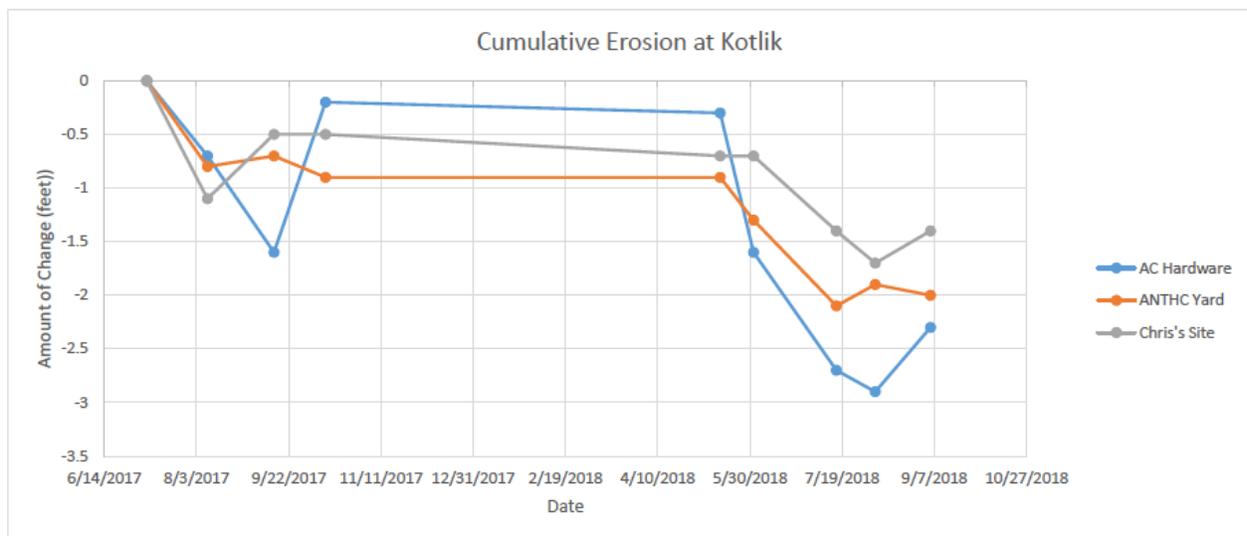
Figure 11: Cumulative erosion measurements in Kotlik at the AC Hardware Store, ANTHC storage yard, and a privately owned site between June 2017 and September 2018, showing 1.5 – 2.3 feet of erosion, provided by DGGS in 2018.

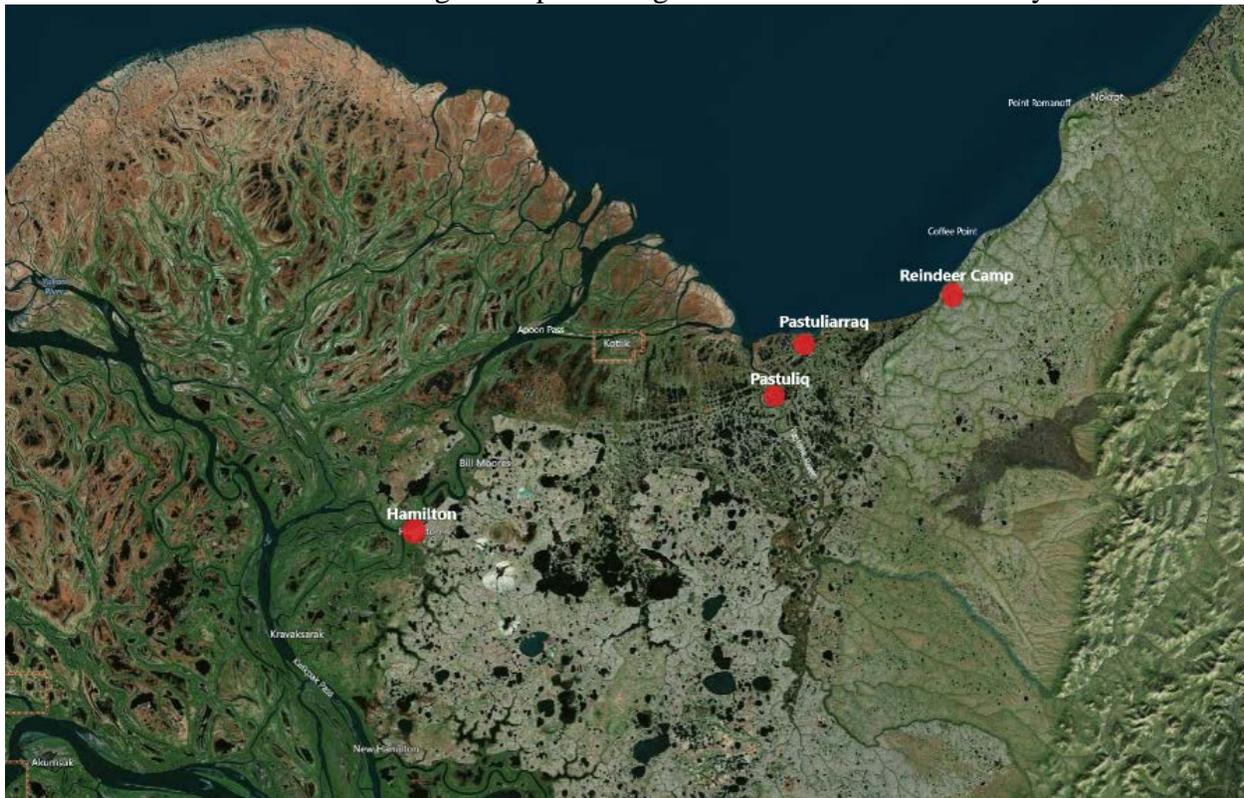
Figure 13. Kotlik relocation sites map. The four red dots on the map indicate relocation sites identified by the community (Map produced by AIJ in collaboration with Victor Tonuchuk and Emmett Matthias (2019), base map generated using Alaska Department of Natural Resources Alaska Mapper, <http://dnr.alaska.gov/mapper/>).
